DOE/NV--1052

Post-Closure Inspection and  
Monitoring Report for  
Corrective Action Unit 417:  
Central Nevada Test Area - Surface,  
Hot Creek Valley, Nevada

For Calendar Year 2004

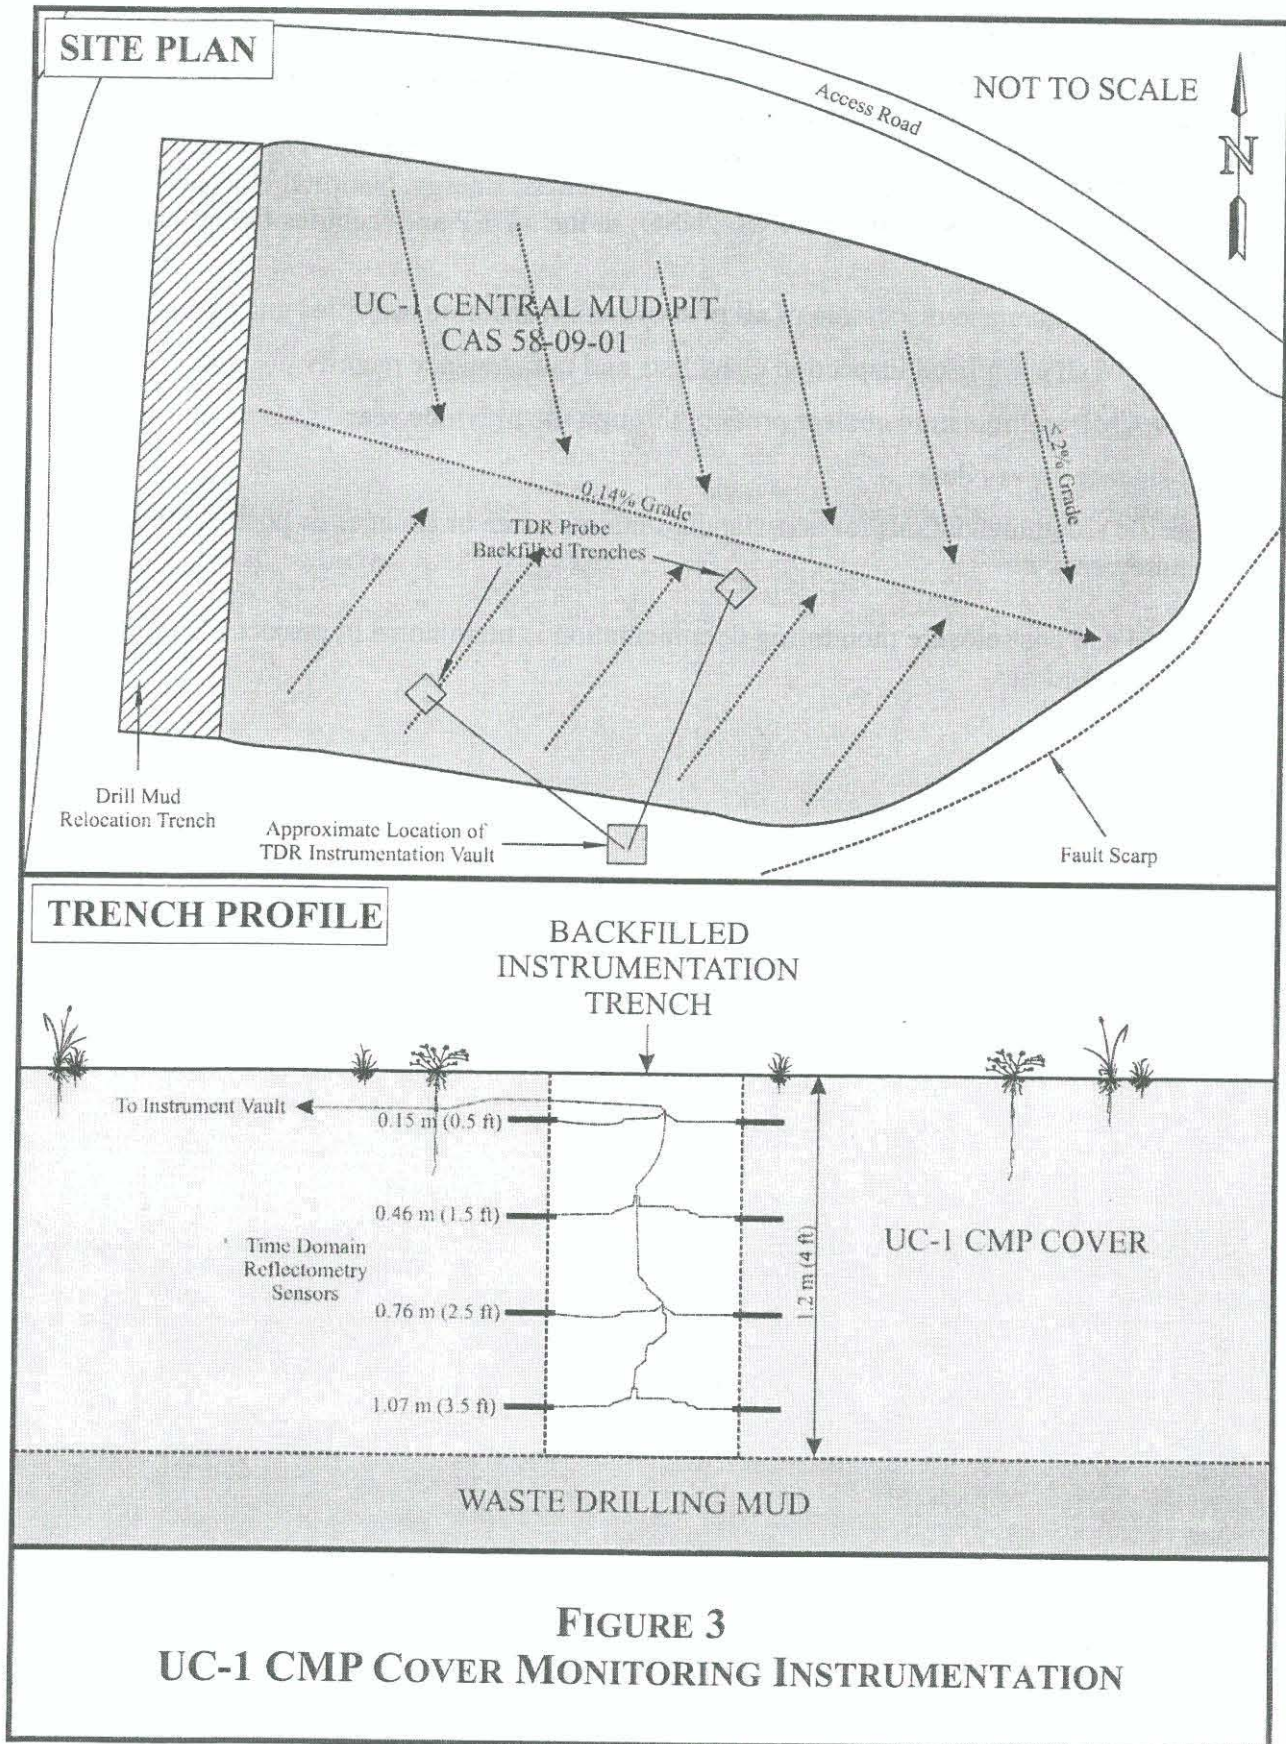
TDR sensors were buried in the cover at two locations during cover construction (Figure 3). At both locations, two TDR sensors were placed at each of four separate depths below the surface of the cover (0.15, 0.46, 0.76, and 1.07 m [0.5, 1.5, 2.5, and 3.5 ft]). The TDR nests are located approximately 48 m (157 ft) northwest and 48 m (157 ft) northeast of the instrument vault, which is located just outside the southern edge of the cover. Data are collected once per day from each TDR sensor and stored in a data logger located in the instrument vault. The stored TDR and precipitation data are automatically sent via a satellite link to an earth station in Wallops Island, Virginia, from which they are retrieved for processing and analysis.

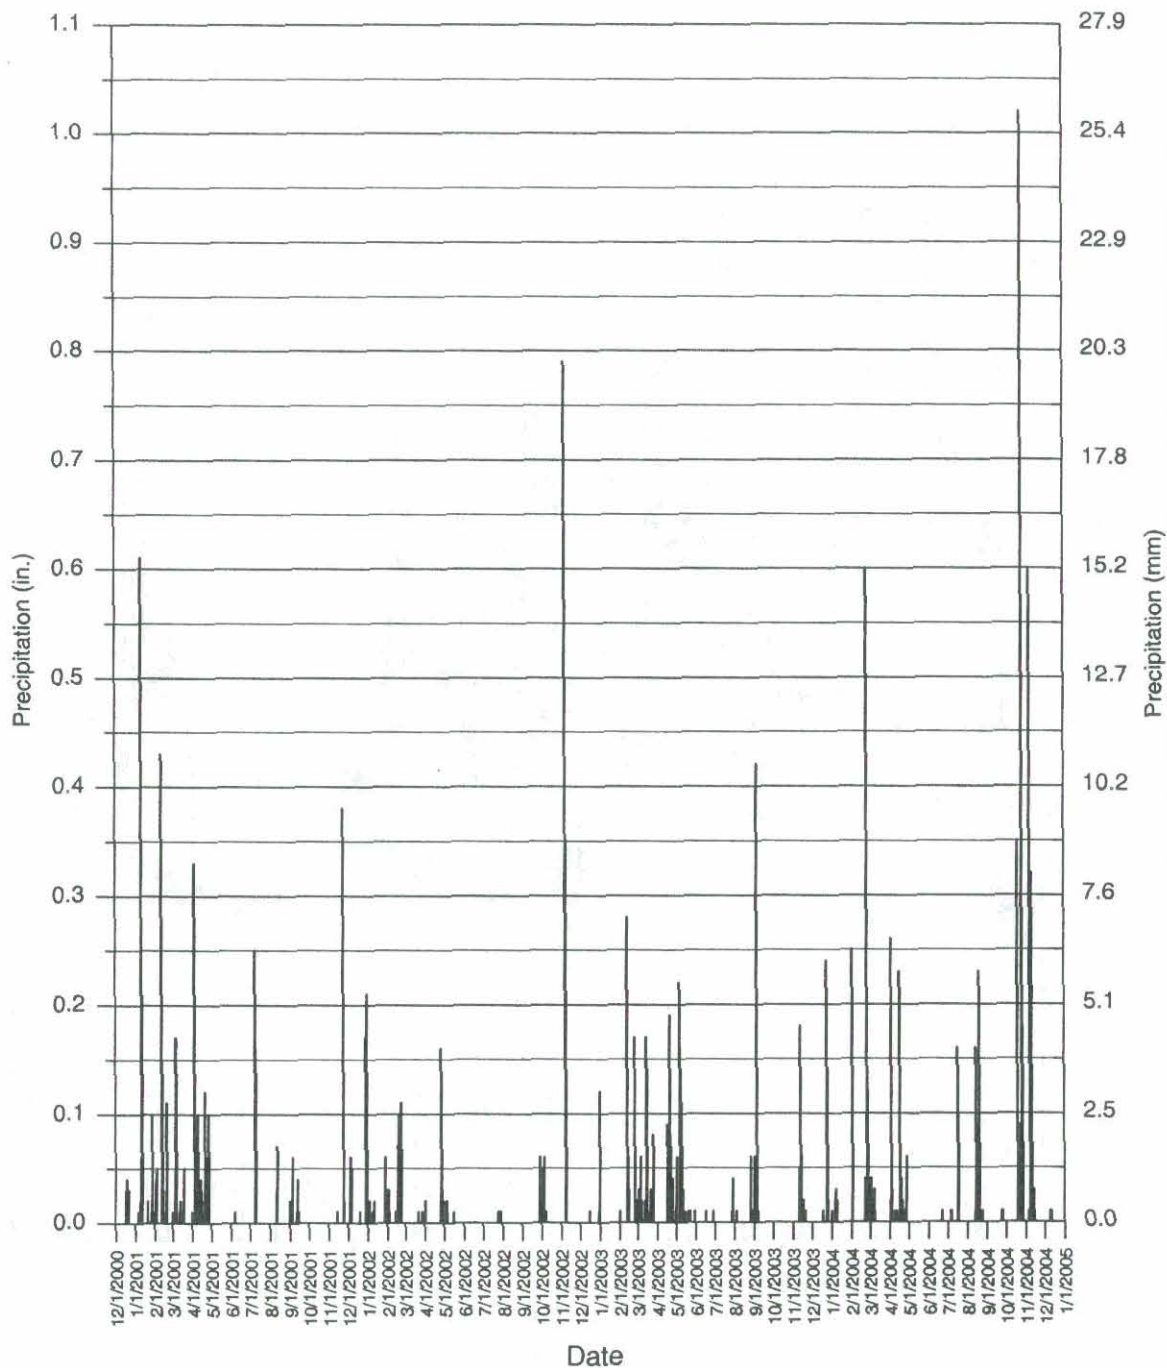
**FIGURE 6**  
**UC-1 PRECIPITATION**

The precipitation record for the UC-1 CMP cover is presented in Figure 6. The total precipitation for Calendar Year 2004 was 15.4 cm (6.08 in.) which is considered above average.

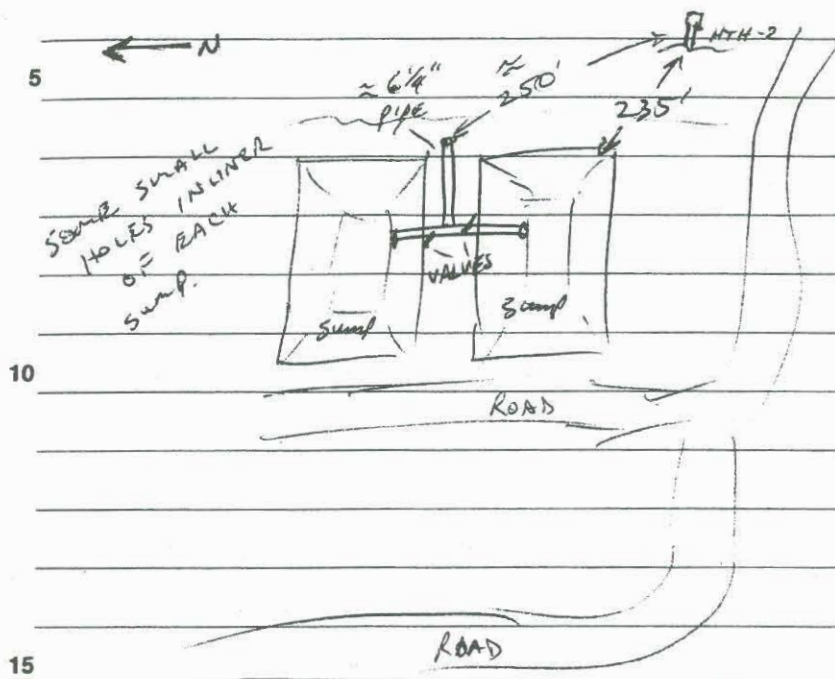
Well HTH-2 & Sumps — 2 lined sumps uphill NW of well head 235' minimum distance

CHECKED ON STATE OF  
SUMPS NEAR HTH-2 WELL.  
MEASURED NEAREST DISTANCE  
AT 235' (WITH TAPE MEASURE)  
DISTANCE FM WELL HEAD TO 6"  
INTAKE PIPE = 250'  
SNTU INTENDS TO USE WELL  
HTH-2 FOR DRILLING PURPOSES  
IN SW CORNER LOCATION  
AFTER WATER IS TESTED FOR  
TRITIUM. BN TO SUPPORT  
INITIAL PUMPING FOR TEST

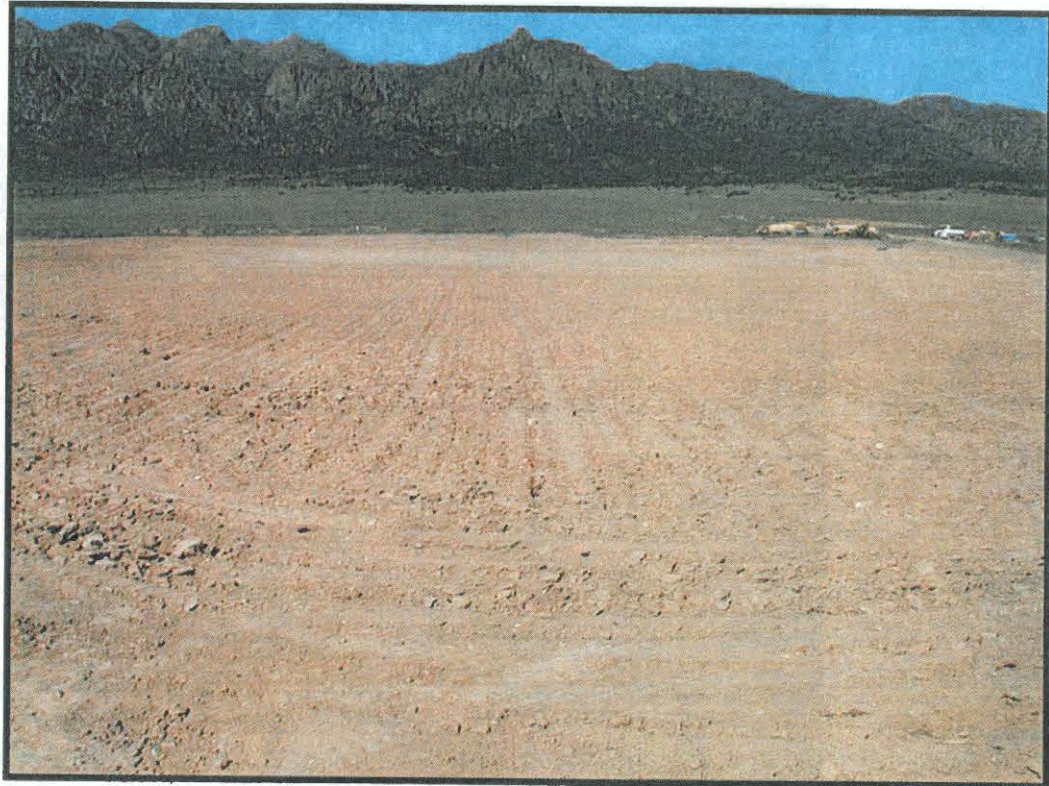
**Figure 4a.**  
UC-1 CMP, prior  
to revegetation,  
Fall 2000

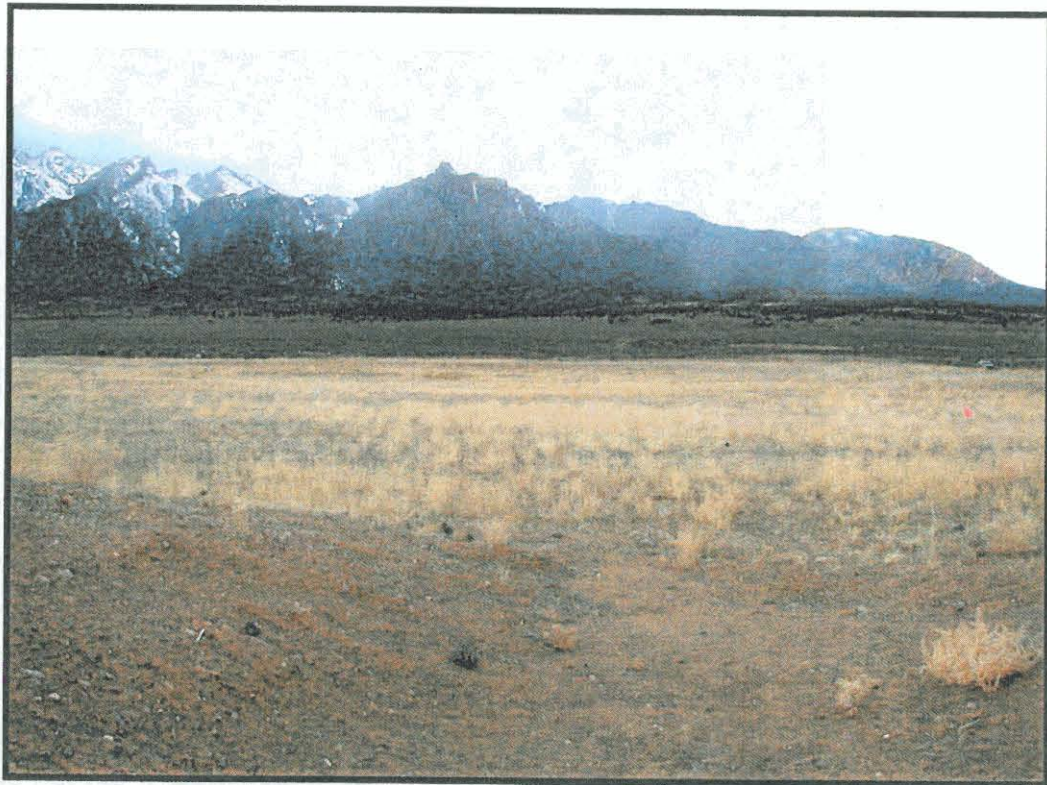
**Figure 4b.**  
UC-1 CMP, one  
year after  
revegetation,  
Fall 2001

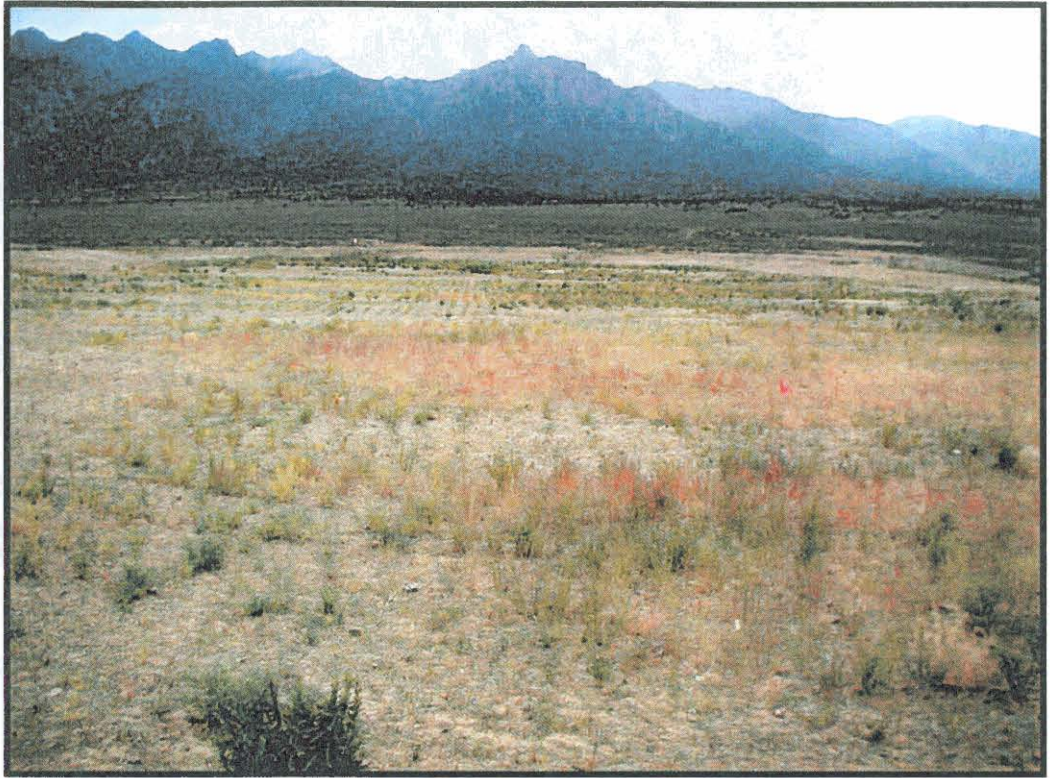
Figure 4c.  
UC-1 CMP, two  
years after  
revegetation,  
Fall 2002

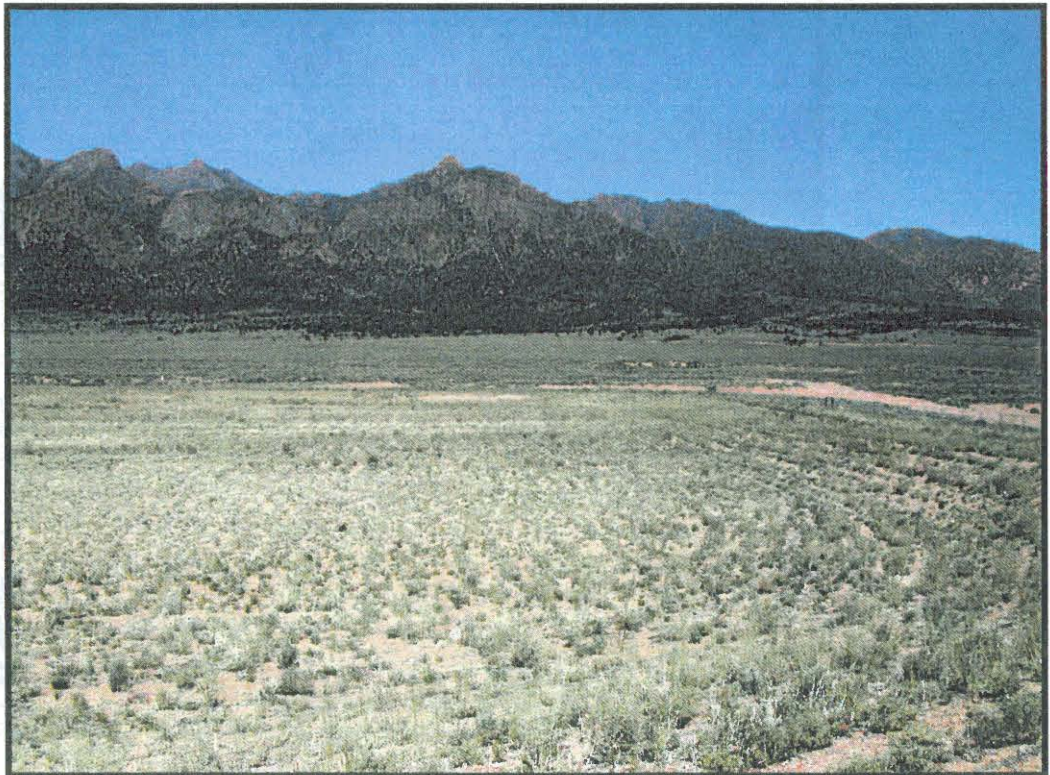
Figure 4d.  
UC-1 CMP, three  
years after  
revegetation,  
June 2003

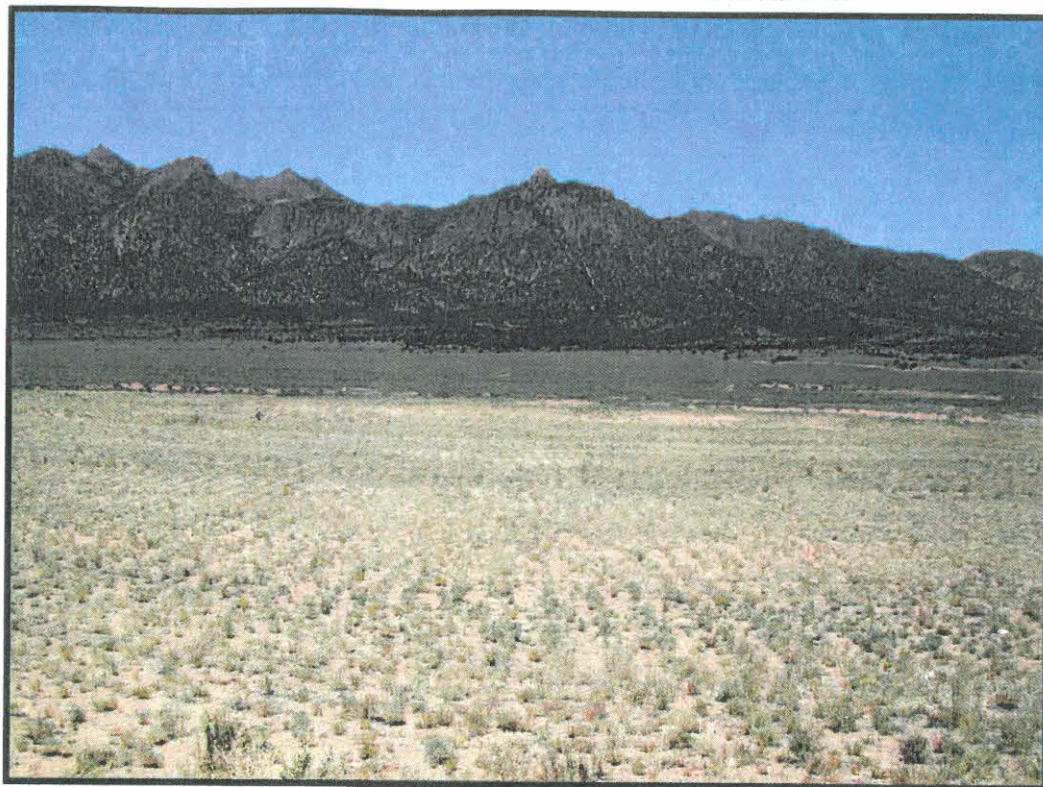
Overall, the plant community is becoming well established on the CMP and on the adjacent disturbed areas (See Figures 4a through 4e). Several species have flowered and set seed. Big sagebrush, fourwing saltbush, two species of rabbitbrush, Indian ricegrass, and squirreltail grass are common on the CMP. Fourwing saltbush, rabbitbrush, and squirreltail grass dominate the plant cover on adjacent disturbed sites and appear to have recovered from earlier browsing. These conditions are encouraging considering the drought conditions the area is experiencing. Based on plant cover and density, the revegetation process is successful.

Figure 4c.  
UC-1 CMP, four  
years after  
revegetation,  
June 2004

Vegetation should continue to be monitored to document any changes in the plant community and identify conditions that could potentially require remedial action in order to maintain a viable vegetative cover on the site, especially on the CMP. Changes in plant cover and/or plant density should be evaluated periodically to ensure the presence of a viable plant community.
